Investigation of health and safety measures in construction sites in Lebanon and Northern Cyprus

Amin Nowfal^a, Beste Cubukcuoglu^b

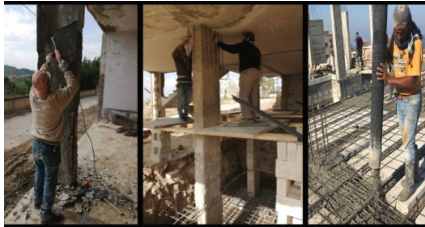
Figure 2. Workers undergoing construction activities without PPE

As can be seen in Figures 2-11, the main concern regarding HS in construction sites located in the Northern part of Cyprus and Lebanon is the lack of PPE. It is apparent that there are no regulations that enforce managers and foremen to make workers use PPE while working under risky conditions. This may be linked to the fact that most of the injuries and fatal incidents might be prevented if the authorities enforced the use of PPE.

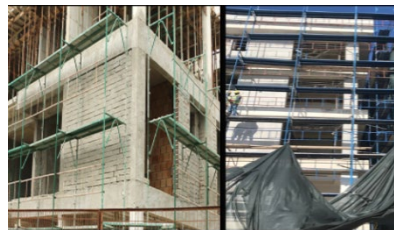
Figure 6. Better form of scaffolding system compared to Lebanon case

The pictures represented in Figures 2-5 were taken in Lebanon and the pictures represented in Figures 6-11 were taken in the Northern part of Cyprus. In Figure 6, better form of scaffolding was observed when compared to applications in Lebanon, it is still not the most appropriate, since although the scaffolds are better assembled than in Lebanon, there are missing boards and bracing, along with handrails and skirting boards on the inside of the scaffolding and in the final sections. In Figure 8, although the workers are wearing the appropriate personal protective equipment, the way of working

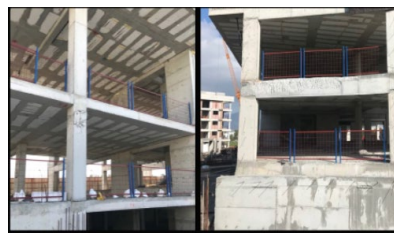
Figure 9. Proper edge protection

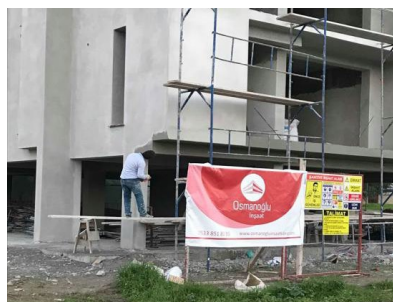
Figure 10. A worker performing plastering without any PPE in a small construction company

- Government and the relevant authorities should strictly monitor the practices of small construction companies
- Strictly enforce the use of PPE, first aid and edge protection in small construction companies.
- Conduct frequent strict supervisory visits, especially in small construction companies.
- Strict provisions of fall protection equipment in all construction companies and perform comprehensive training programs on how to use such equipment.
- Provide more educational programs regarding HS and raise public awareness via the media.
- Provision of more professional HR staff to take care of small construction companies.
